# Home Inspection Report

- Address
- City, State, Zip
- Date:

Property Information: Single Family, 3 bed, 1.5 bath, 1358 sqft, built 1992

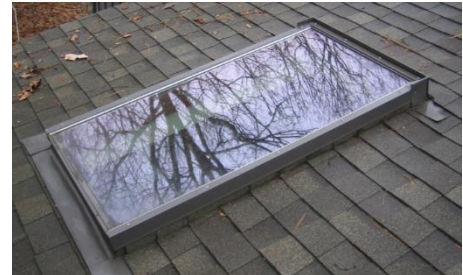
Roof. Home is still covered with original asphalt roof installed in 1992. Shows no major signs of damage. No missing shingles or similar problems the roof is 24 years old and replacement should be considered. Roof is penetrated with 3 large sky roofs in the south side of roof. In the garage there is a significant blow out in the ceiling drywall from water damage.

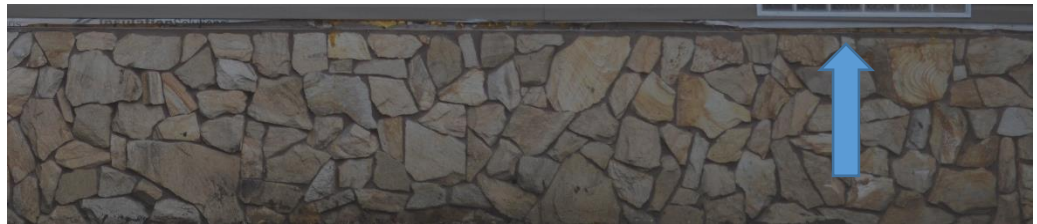
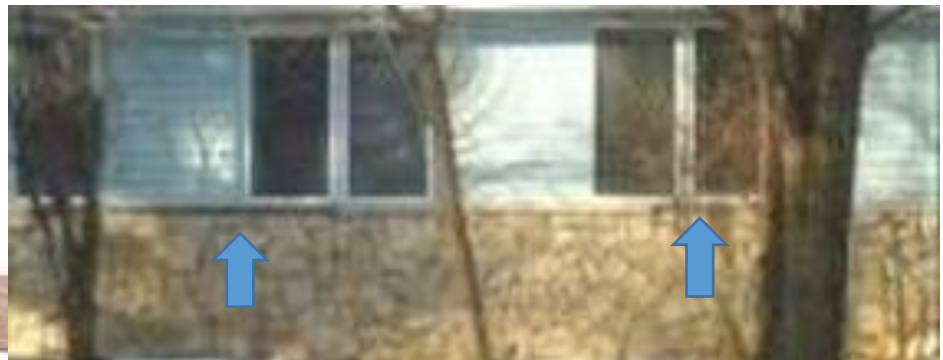
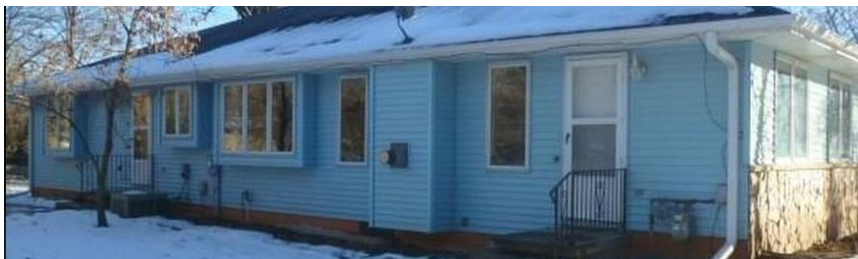
Stone Brick Veneer; Is in excellent shape however the stone cap is missing in several locations. Replace all the stone cap is more viable than piecing in parts. I added a sample of what the cap might look like.

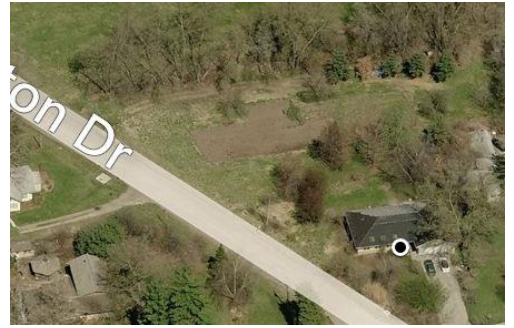
Yard. Property has a very unique 0.47 acre lot. Is a triangle shape with street boarding on 2 sides. A corner lot. Potential for growth. Second home or out buildings. Note; second street, is gravel.

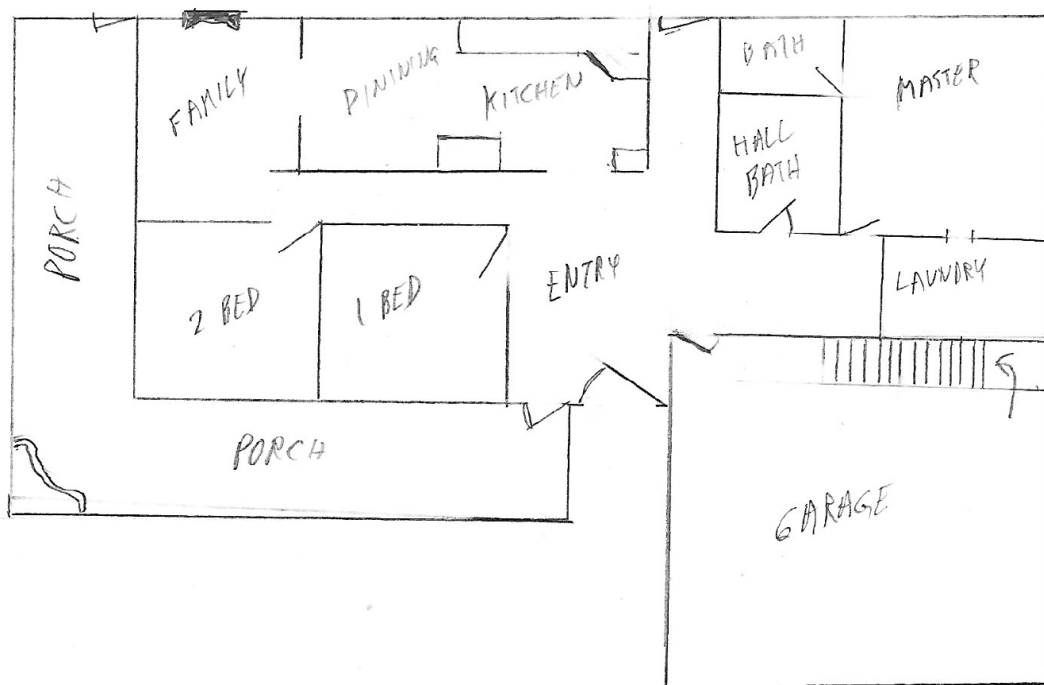
Inspection Report: Interior, most striking feature of this home is the huge enclosed porch or solarium. Home was specific built to accommodate this feature. Porch foot print is 400 square feet; it takes up 1/3 third of the homes floor space. Unfortunately, this leaves only 900 square feet for actual living space. The bedrooms are quite small. I believe the only way to properly understand the significance of the large foot print is to see a floor plan of the home which I have included here. Drawing is not to scale. Most rooms are 10 x 10 or 10 x 12.

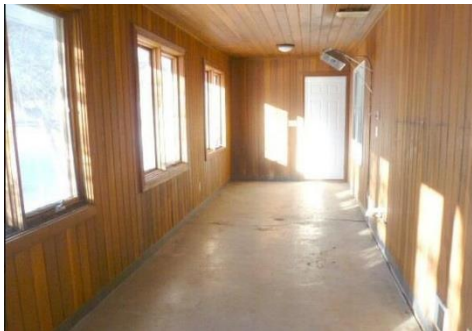
There's even a place to  
Plant your plants. There  
However, there is an odor  
to the porch. Need to take humidity readings and  
determine if further action is necessary. I would  
also look at removing the dirt as the smell was  
most significant in this area.

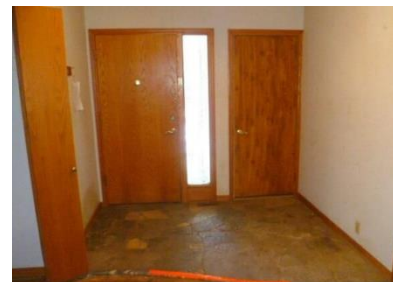
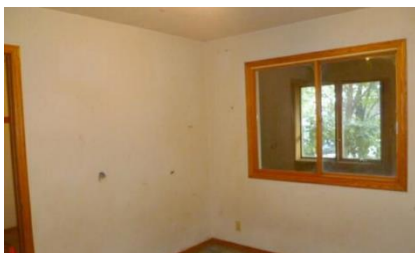
Interior trim is in basically non-salvageable  
condition. I believe every interior door has a hole in  
it.

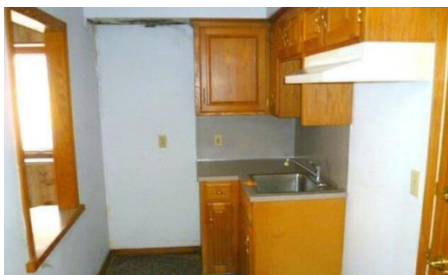
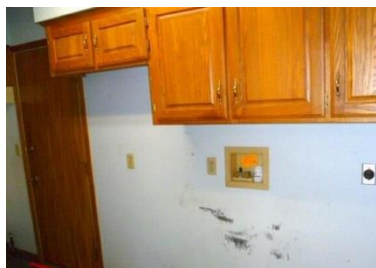
Here is the laundry room. It is set up as a second kitchen with a sink and space for a stove, with vent hood and refrigerator. Use caution when installing 2 stoves in a house. This may be illegal for various reasons. Also, notice the pass through to the

master bedroom, again. It is possible this area was used as office space and not a bed room.

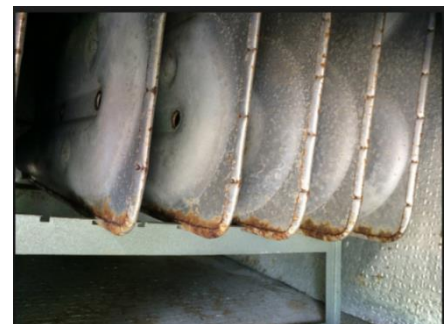
Heating cooling equipment is 24 years old. Has had high moisture content air due to porch?  
Recommend replacement. Heat exchanger is showing signs of deterioration. Same concerns with air conditioning.

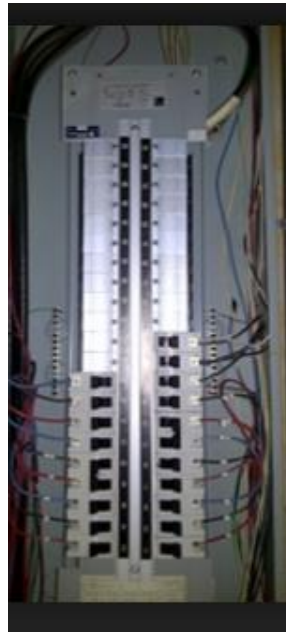
Electrical. 150 amps, grounded in 2 places and all lines secured no issues unless rewired.
