- Home Inspection Report #1
 - Address
 - City, State
 - Date:

Property Information: Single Family, 3 bed, 1.5 bath, 1128 sqft, built 1963

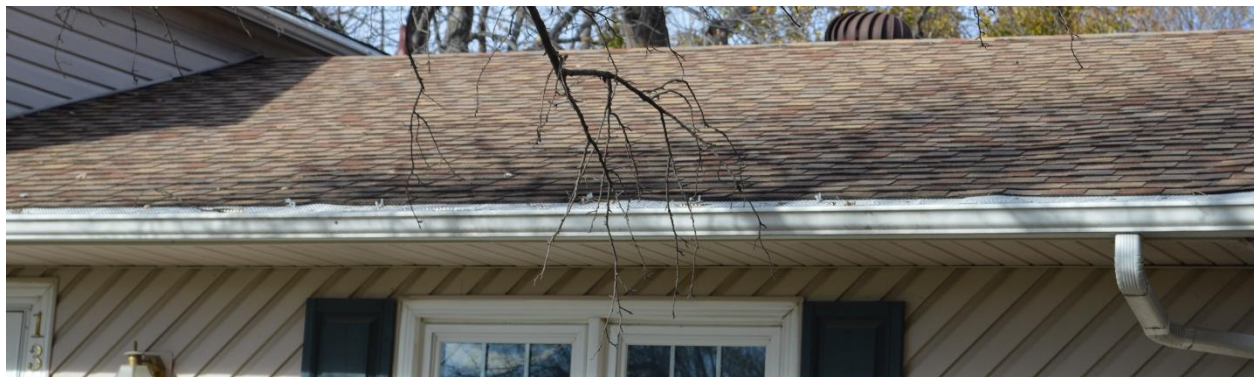
Roof: Fiberglass singles in serviceable condition with no issues found. Roof reported to be 11 years old.

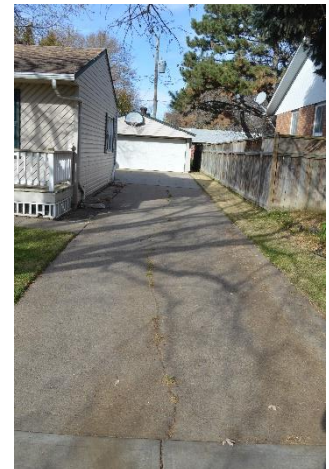
Fence. 3 ½ -foot high chain link fence on west and north sides of property. Both are in serviceable condition. Picture of small portion of chain link fence on page 13 near air conditioning condenser. On next to driveway is 6-foot wooden fence. Is in serviceable condition. No rot but wood parts are warping out of position. Gaps between planks are noticeable. Will probably need repair/ replacement in the next few years. Notice sag in picture. Note; this fence is owned by next door neighbor.

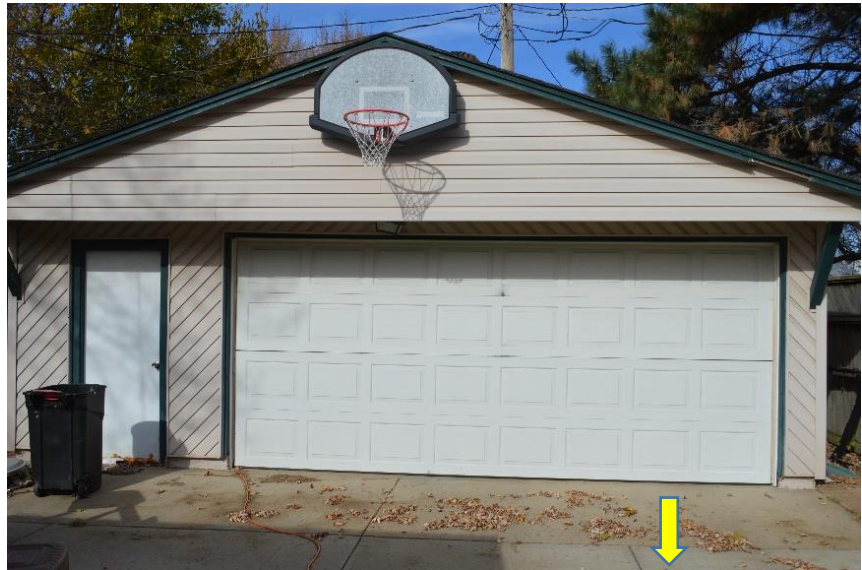
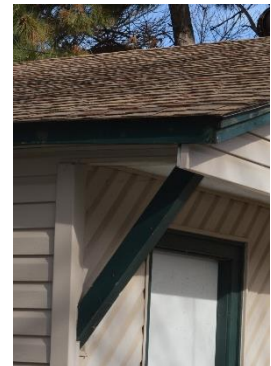
Garage. 400 sqft detached 2 car garage at rear of property. Garage door opener, all wiring in conduit, lights switched both inside garage and inside house at 2 locations. Temperature controlled exhaust fan. Basketball backboard. Passage door while secure needs replacement. There is a bend in the roof at the point of the overhang. This should only be a cosmetic issue as the overhang is supported with braces. If concerned, can have a framing contractor investigate. Roof is same age house roof. About 11 years. No issues found.

1. Deteriorated rear door. \$150.
2. Deteriorated garage passage door \$150.
3. Leaking gutter rear of sun room \$25.
4. Front door lock. Will not turn. \$100 - \$150.

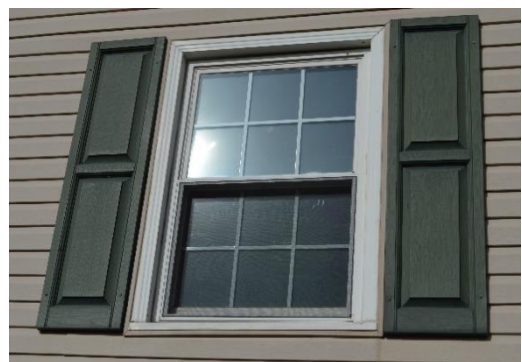
Windows: All windows on house are double paneled vinyl windows of good construction and are in very good condition. Except for 1 kitchen window which has a cracked pane. Window has not fogged indicating still gas tight. Windows on front of house and east side (driveway) have decorative fiberglass shutters. Shutters could use a coat of paint. This is entirely cosmetic.

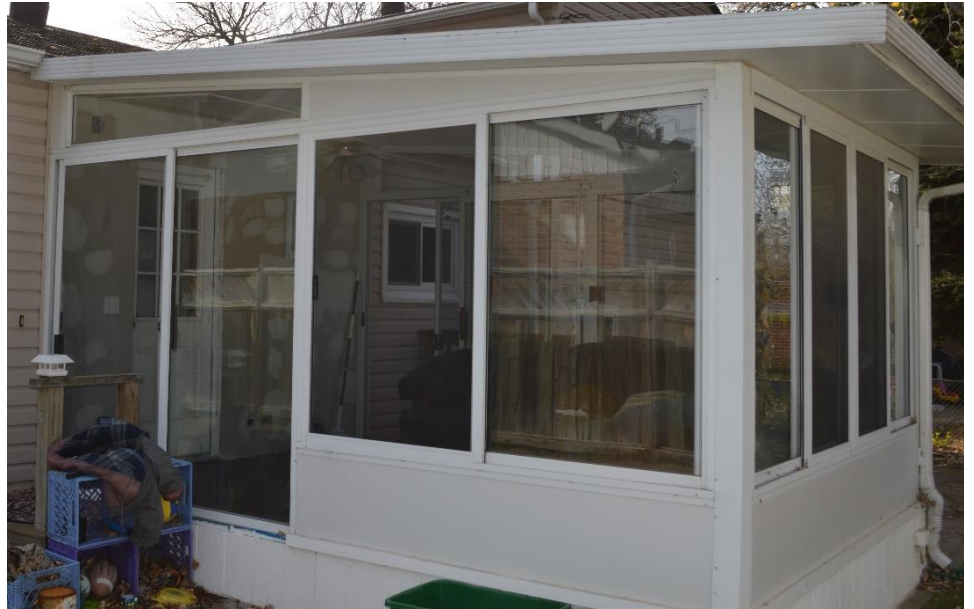
Gutters and downspouts. In overall in serviceable condition. Exception; gutter on sun room is leaking. Evidence by line in lawn at end of room. This gutter is integral

Sun Room. Attached to the rear of the house is a 9 by 14-foot sunroom. Is fully screened and has lockable sliding windows and doors. Has lighting and ceiling fan. Newer wood siding installed around the base.

to the sun room. Simple repair by caulking interior of gutter. Note clean gutter first. All downspouts are provided with water diverters.

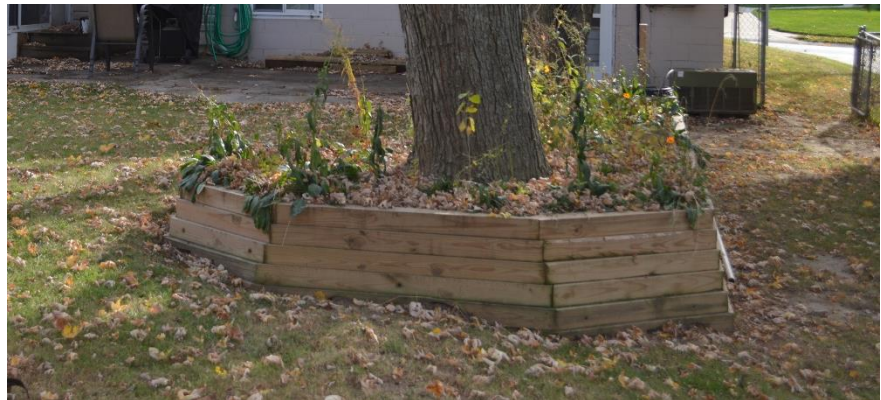
Property is mostly grass with minimal bare spots. Area to side of garage and rear is gravel. Needs to be cleaned of weeds and pine needles. There is a landscape feature retaining wall in the backyard. Appears to be well built and solid. Weep holes for drainage are provided on the lower side.

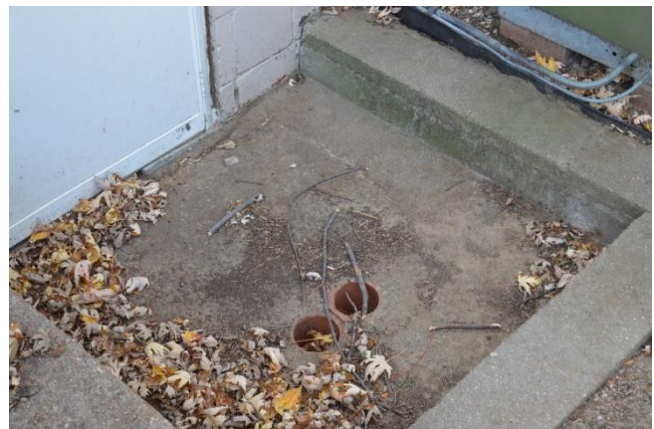
All ground appears to slope away from house. Rear door to basement has a below grade landing. Dry well is connected to this landing and flooding is not an issue. However, before drywell installed area did flood and rear door (bottom) shows signs of deterioration. Door is also very thin

and not a good barrier to temperature extremes. Recommend replacement of this door with a modern steel insulated door. There is a storm door on exterior here that is in good condition.

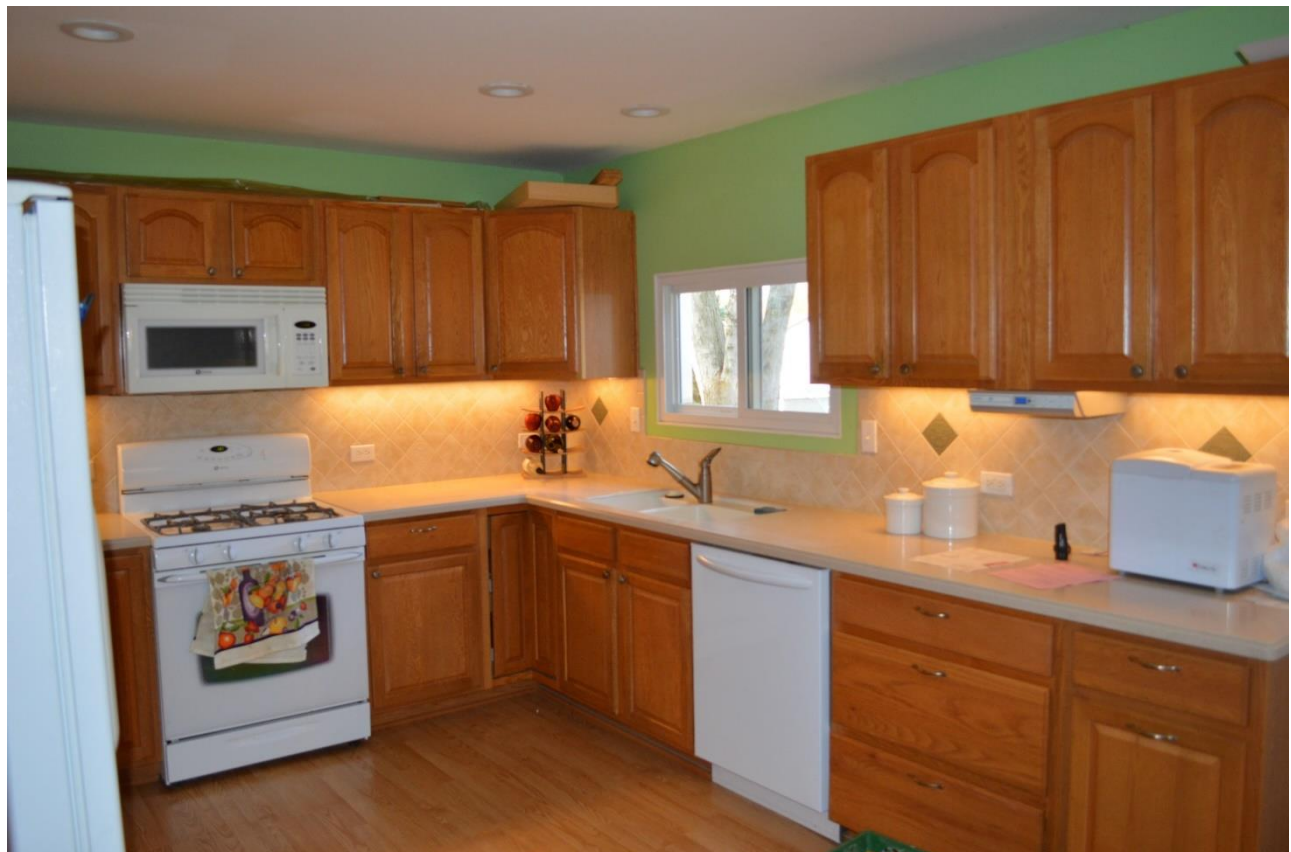
Kitchen is of newer design with midgrade oak cabinets and solid surface Corian counter tops, sink is formed into counter top. No lip. Backsplash is tiled above all counter tops including desk area. Features LED recessed can lighting and LED undercabinet lighting. Has a very large pantry. Laminate flooring is slightly worn out and could require a replacement for cosmetic reasons. However, is functional and no safety issues observed. (Picture of desk next page).

1. Laminate flooring kitchen. (150 square feet) \$600
2. Kitchen rear door. Replace mullion \$55 – \$75. Replace door \$200
3. Replace rear patio. Demo \$400 + New concrete \$1,650 (\$2,000 +)
4. Wood deck over existing concrete. Would provide great foundation. \$4000.
5. Retile tub surround due to mildew. \$500.
6. Retile hall bath due to cracked tile. \$125. Back up floor to prevent new tile from cracking. \$50.

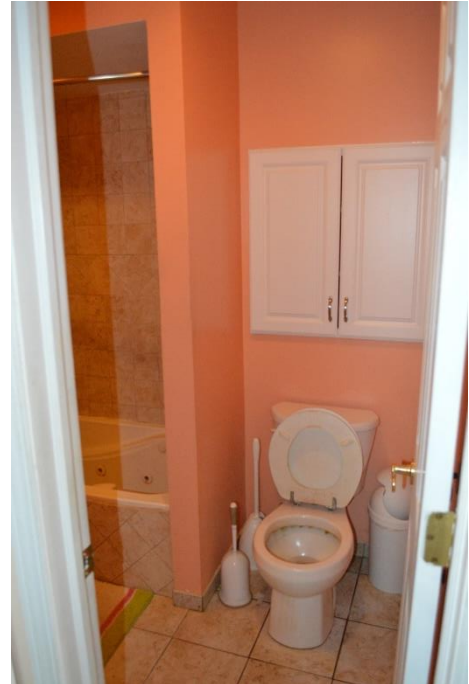
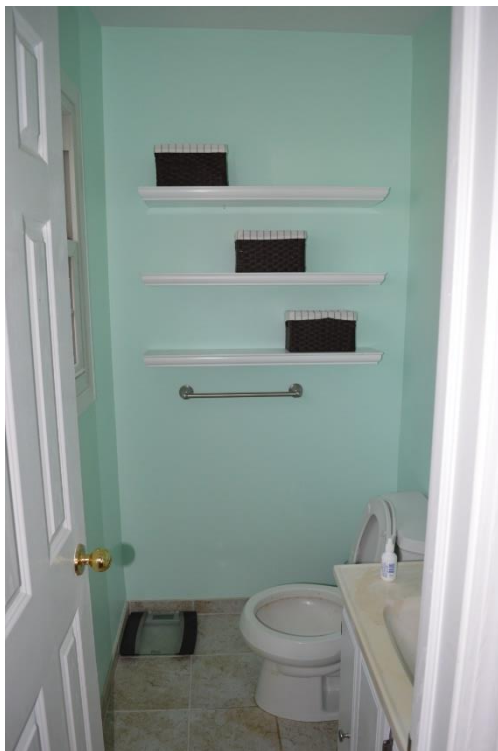
Hall bath (full) is slightly dated and could use a color change. Tub surround is tiled. Is showing signs of mildew at base of tile. Tub is an inexpensive single person whirlpool tub. Shower valve is of pressure balance design. Curved curtain rod. There is one crack in ceramic floor tile. Otherwise solid. Toilet is secure and a water saver design. Unique storage cabinet installed in the wall above toilet.

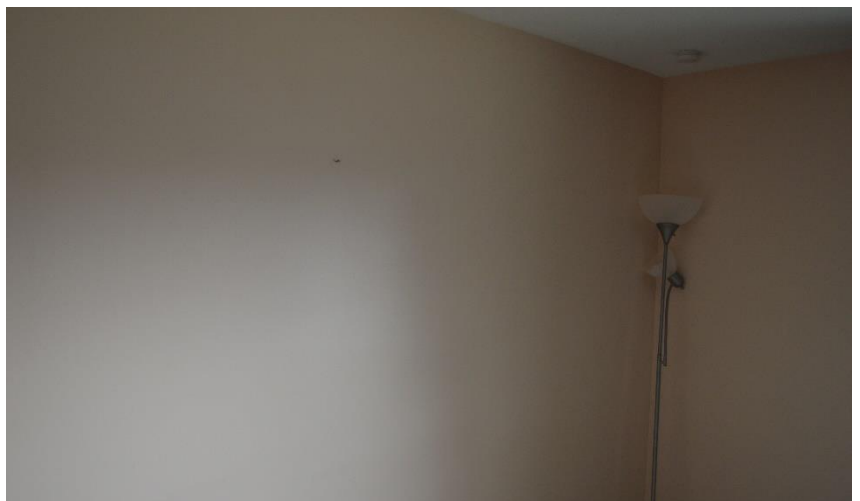
Interior drywall and trim is in very good condition. No issues found. Colors are mostly neutral. Kids bedrooms are a little wilder. Door and trim paint is also in serviceable condition. Stairway

railing to lower level family room needs to be painted. All bedrooms have ceiling fans on independent switches.

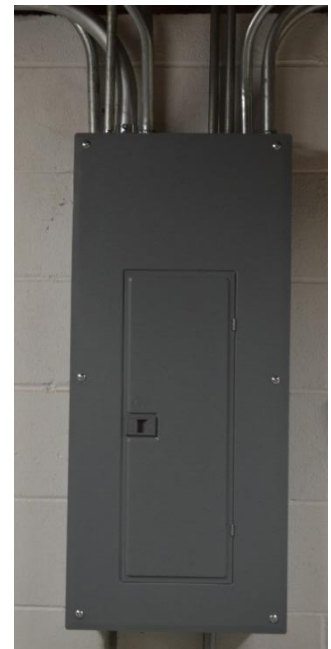
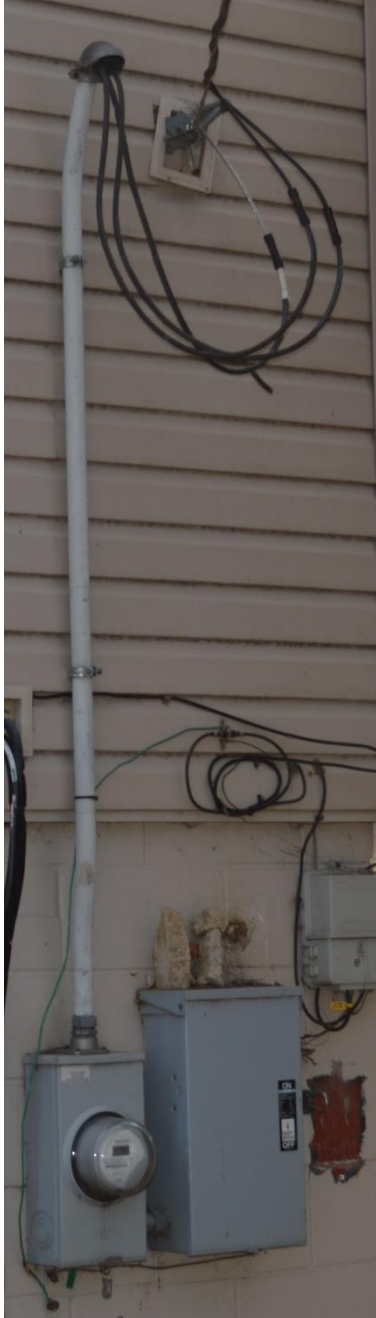
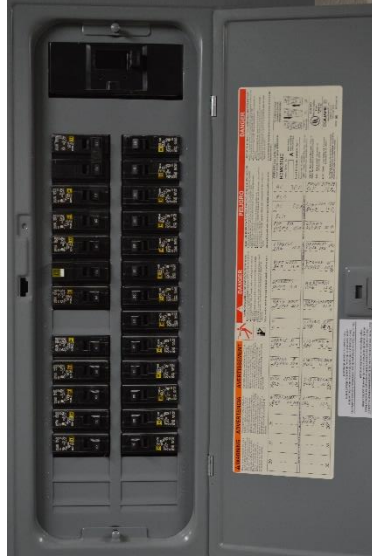
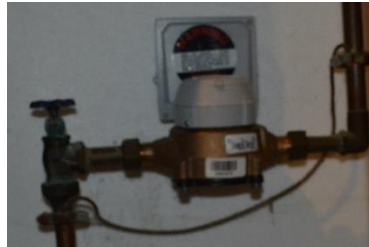
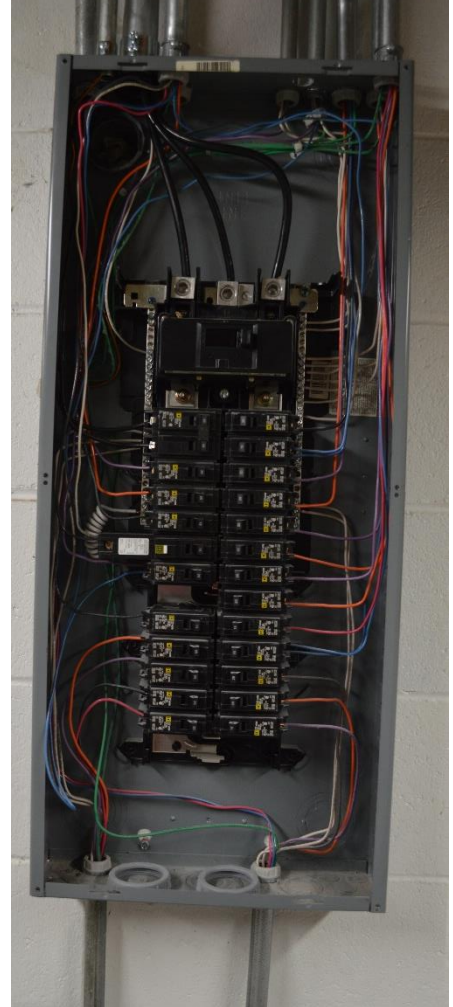
Electrical: Newer 150 amp Siemens electrical panel. Panel is correctly labeled and has arc flash breaker installed for bedroom outlets. This conforms to an older electrical

standard, which is both legal and safe. Wiring inside panel is neat and orderly. Panel has 2 grounds. There is a grounding rod under electric meter, and grounding through copper house plumbing. There is a grounding wire around water meter as required. Nearly all house wiring in mechanical / laundry room is in conduit. Preferred method of routing wires. Meter box and disconnect

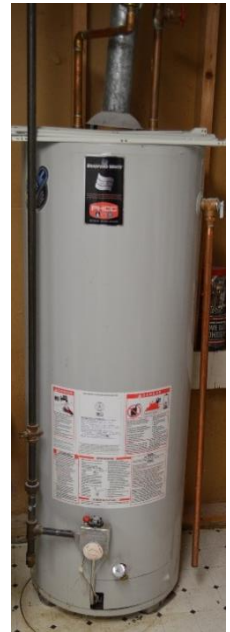
Water heater. Tank type, older. May consider replacement.

3. Water heater (\$600)

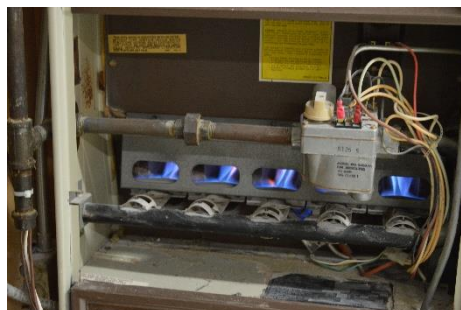
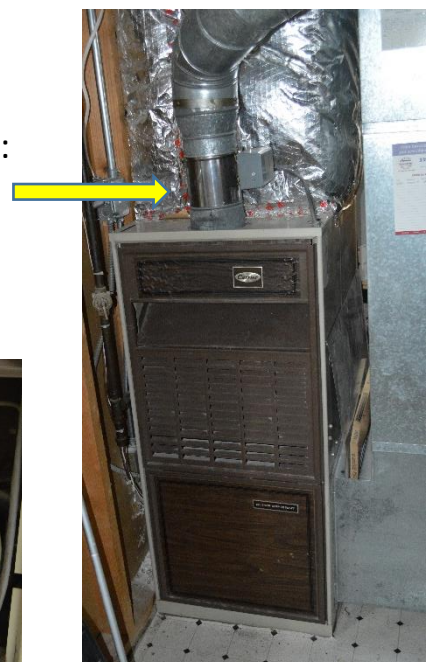
Furnace: Carrier, Model: 58S125-3, Series: 314, Serial No: V1A25460, BTU: 125,000

Furnace is equipped with an electrically controlled flu damper which makes furnace 75-80% efficient.

Furnace when operating has a nice blue flame. A blue flame indicates proper combustion when using natural gas.

Using data from serial no. determine manufacturing date to be August of 1981.

Even though furnace is operating properly and showing no signs of improper operation. Should probably conceder replacement of furnace in the near future due to age of equipment.

1. Furnace. Standard efficiency \$1700 High efficiency \$ 2100

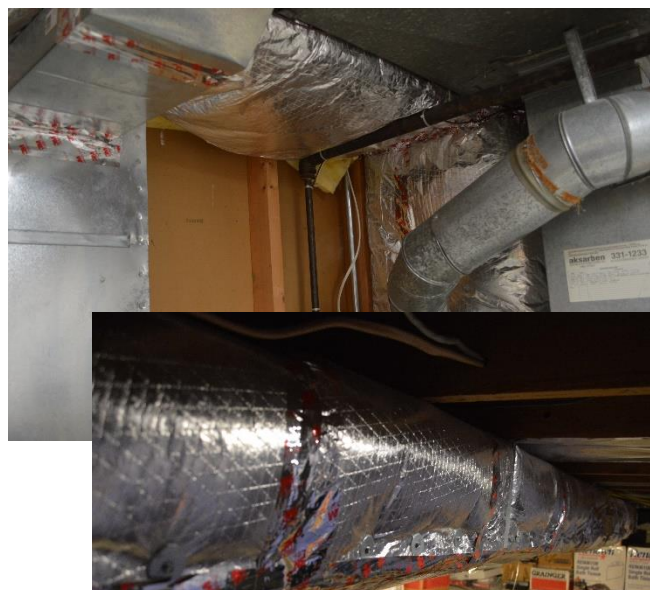
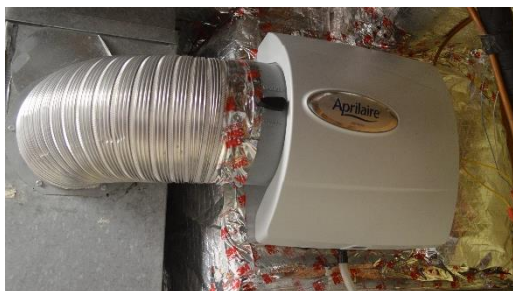
To improve furnace (heating) and air conditioning (cooling) efficiencies main supply line is insulated entire length of house. Furnace plenum (large duct on top of furnace) is also insulated.

Furnace is equipped with an Aprilaire™ humidifier. Newer install. Media needs replacement. (normal maintenance)

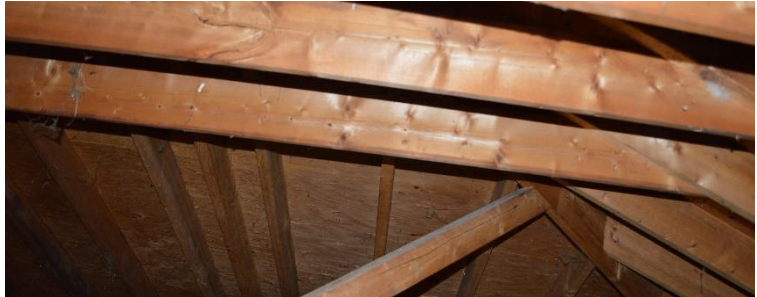
Attic; This house has 2 access points due to 2 separate roof lines. In both attics, no water infiltration, animal feces or nests found. However, insulation is nowhere thick enough. Current depth is about 4". In Omaha recommend attic R-value is 38 to 60. R-30 is approximately 6 ¼' fiberglass batting or 12 inches of cellulous fill. Recommend blowing in till a finished depth of 30". This gives a recommend value of slightly over R-60.

4. Insulate attic with blown in insulation \$850
