- Home Inspection Report
  - Address
  - City, State, Zip
  - Date:

Property Information: Single Family, 3 bed, 3 bath, 1375 sqft, built 1960

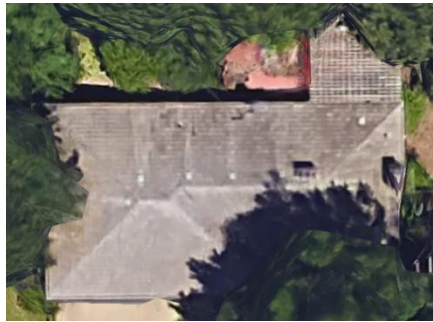
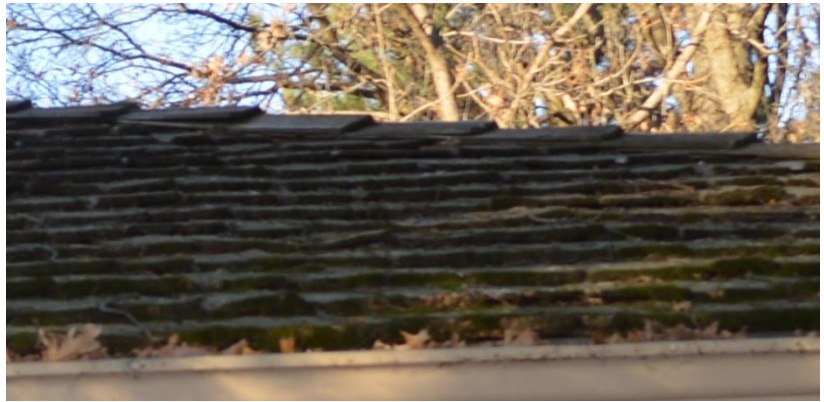
Roof; Roof is original and made of cedar which makes it 56 years old. The cedar shingles are in serviceable condition. There is algae growing on south facing roof and needs to be washed off. There is some occurrence of missing shingles. These will need replacement.

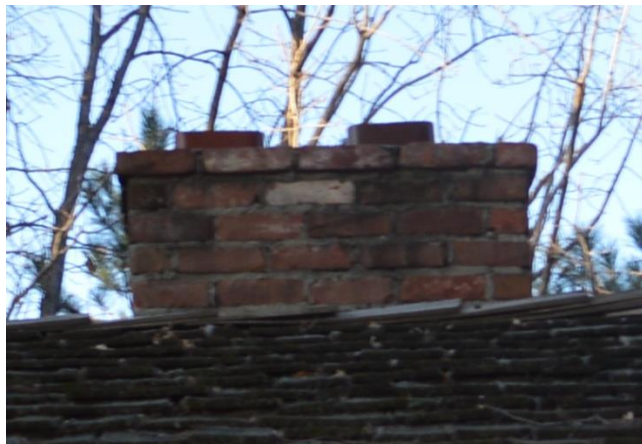
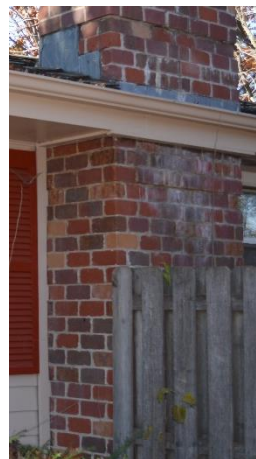
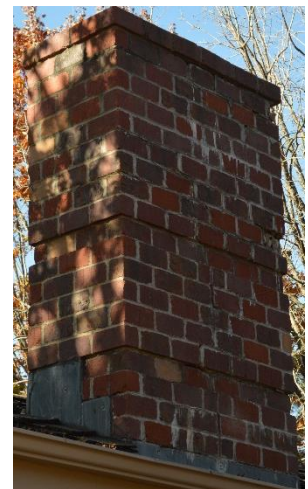
Chimneys; House has 2 brick chimneys as house originally had an incinerator. The east chimney will require some tuckpointing work and cleaning. There is some effervescence (salt deposits) on the brick. There is also a fire place and any chimney on a fire place should be fitted with a spark arrestor and be cleaned of any deposits of creosote. There are lots of trees around this home.

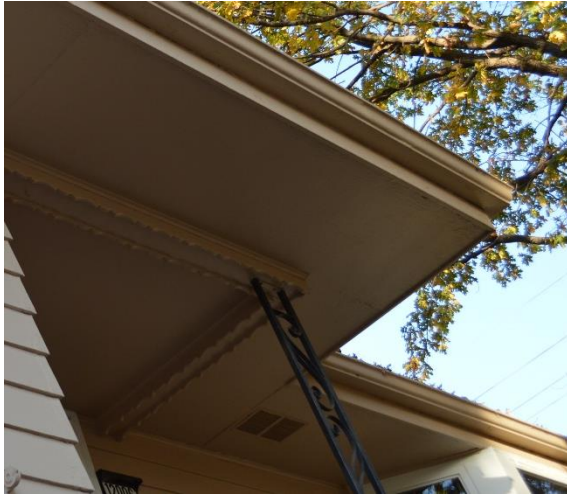
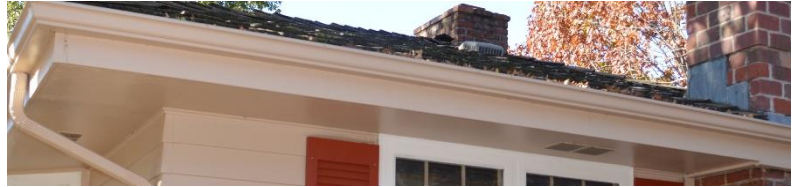
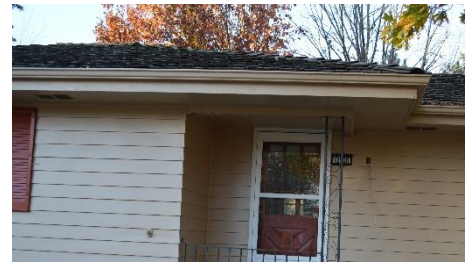
Gutters and Eaves; Gutters are in good condition and freshly painted. No evidence of leaks found. However, need to be cleaned out. This is a maintenance item and will be required yearly with the number of trees around this house. Gutter covers or grills can be installed to reduce or eliminate the need to clean yearly.

Eaves: Freshly painted with no missing or damaged pieces. Eve vents placed every few feet to provide attic ventilation.

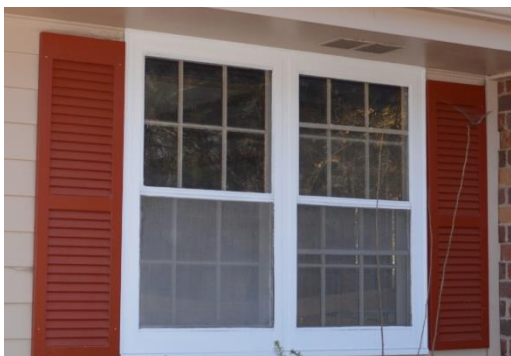
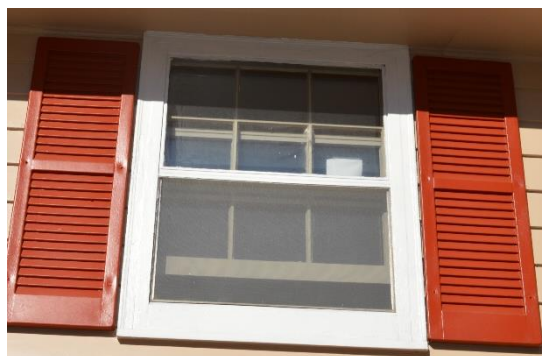
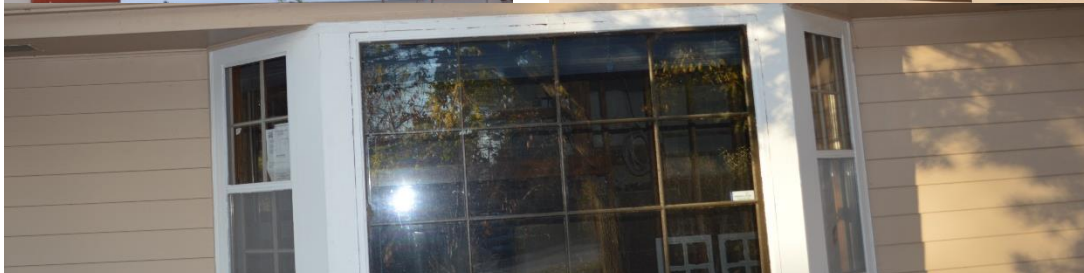
Windows; Wood with metal tracks and aluminum storms. In good operation condition. No broken panes, no nonfunctioning windows except for one basement found. No evidence of leaks. Freshly painted inside and out.

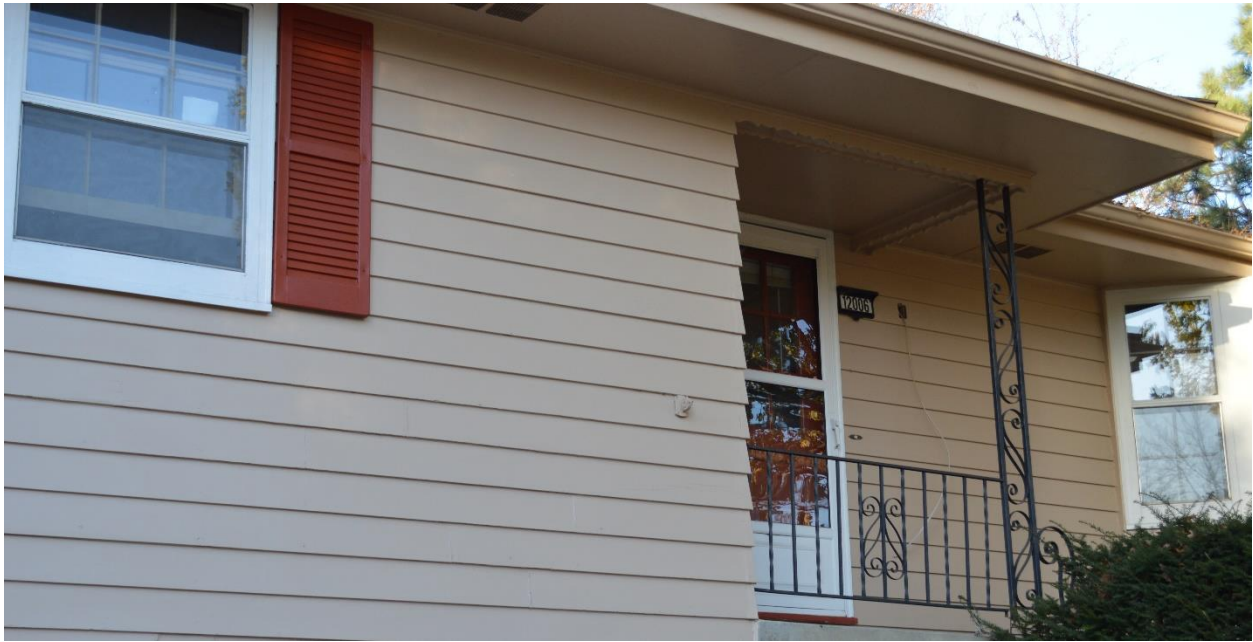
Exterior; Freshly painted wood siding. No missing pieces found. House looks very good. Windows on the front and east side have nonfunctioning fiberglass shutters that have been painted a contrasting color. Garage doors in original picture have not been painted. They are slated to be replaced (white).

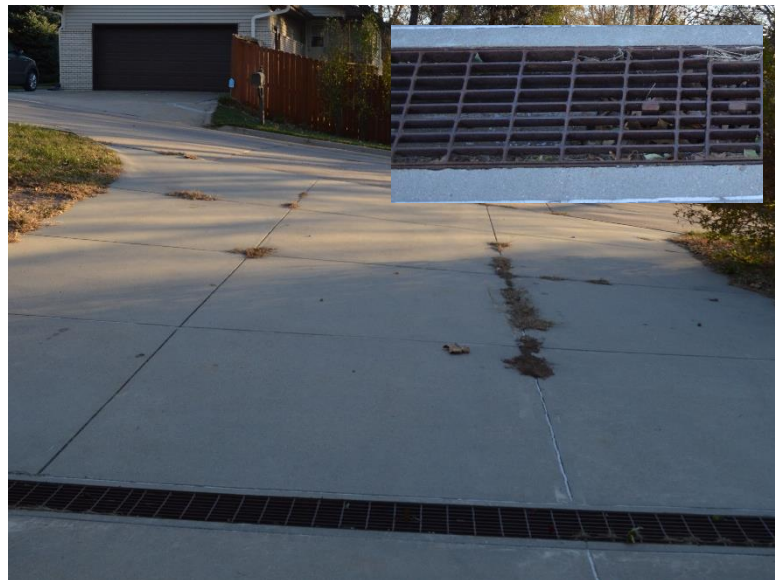
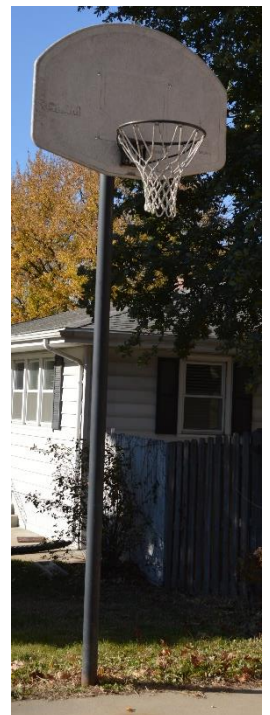
Driveway; In very good condition without a single crack found. There is a covered drain or gutter that runs across the center providing drainage as foot of driveway is higher than entrance to garage. Metal grate on drain removes easily for cleaning. This is another maintenance item that will require periodic attention. Also included is a basketball backboard.

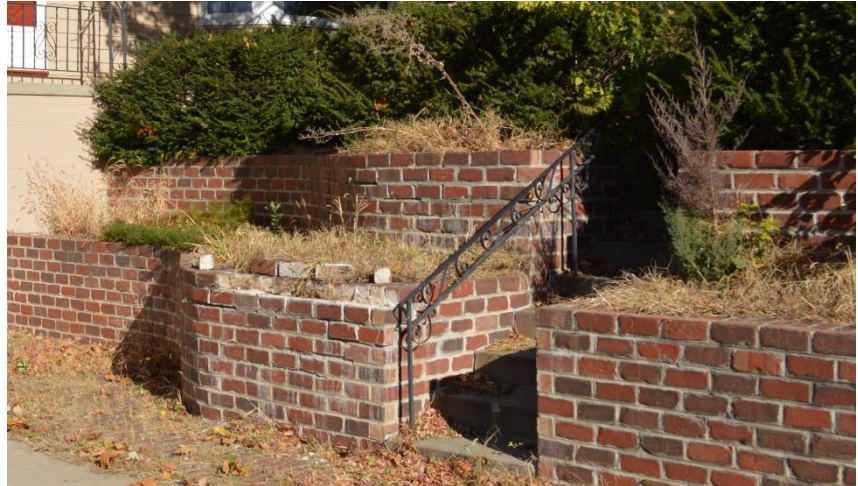
Retaining Wall; on east side of driveway is a brick retaining wall. Wall will need to be tuckpointed. Mortar dried out and falling apart along top edge. Notice bricks on top of first wall. Otherwise overall wall is solid and

of good construction. Is level and shows no evidence of movement. Is also in need of weeding and trimming of vegetation.

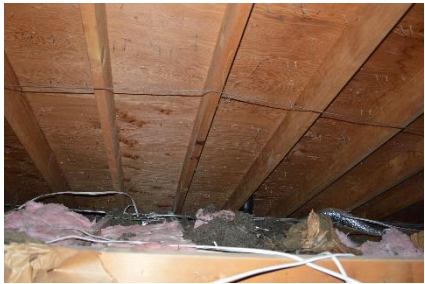
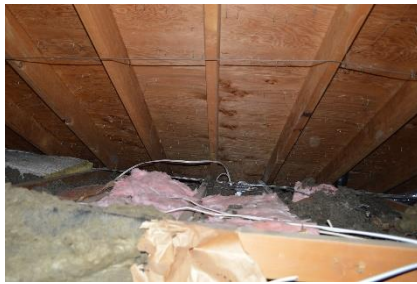
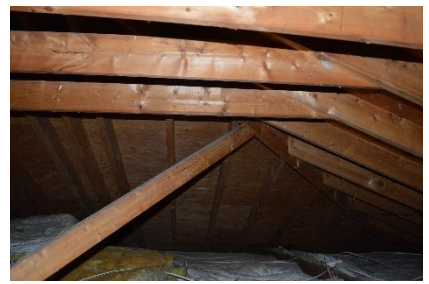
No items to report other than minimal insulation. No indications of water or pests. In Omaha need between an R-38 or R-60. A 6 1/4" bolt of fiberglass or 12" of blown in cellulose equals about an R-30. Existing bolts are about 6" thick. Will be blowing about 30" on top of that when electrical work is completed.

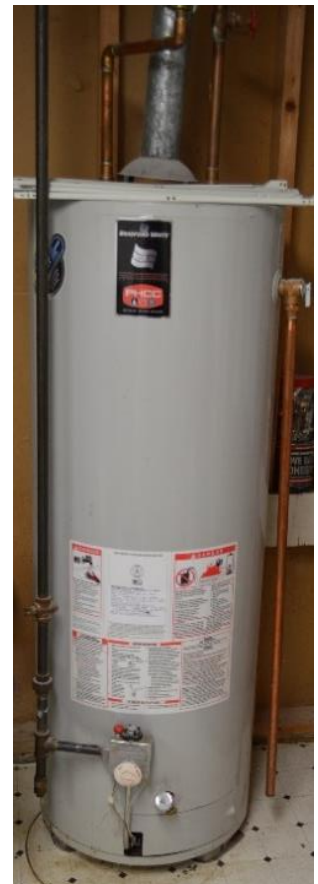
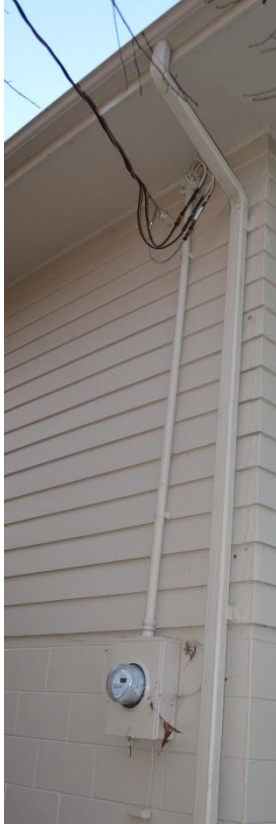
Plumbing; House is completely plumbed in copper. Both supply and drain lines. Water feed from city comes in via lead entrance piping. This is common in a 1960's home. May consider installing filtering device(s) to remove lead from drinking water. Note; water filter on refrigerator does remove lead for ice maker and door dispenser. There is no water softener. Drain line to street is cast iron. Is susceptible to damage from tree roots. Has been scoped and is free of roots.

Hot water heater is in need of replacement as well. Drain valve leaks.

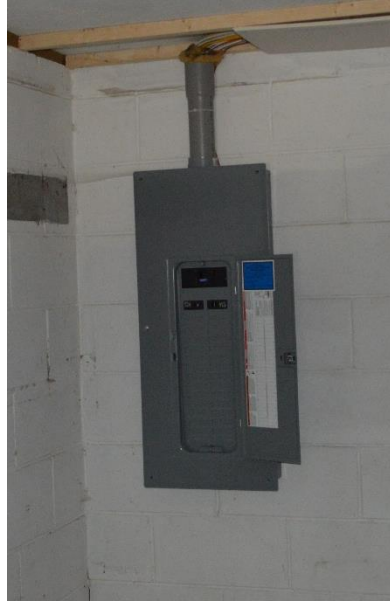
Electrical; Brand new code compliant electrical. There is a arc-flash breaker on every single power outlet and lighting circuit. This is the same standard you will find on a brand-new house.

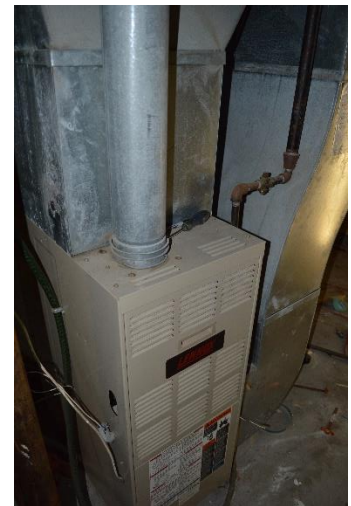
Furnace is a Lennox model G23Q2/3-75-1

Serial number is S/N 5893K54338

G is for gas, 2/3 means 2 to 3 ton drive, a ton of cooling requires 400 CFM. The fan on this unit will move between 800 and 1200 cubic feet of air per minute. Capable of operating a 2 to 3 ton air conditioning unit. Heating output is 75,000 BTU.

From serial number we can determine manufacture date.  
Oct. 93

Air Conditioning unit is a Coleman model 7036-811 Serial Number is 048505624

3 ton unit manufactured in April 1985.

Recommend replacement of both of these units due to age.
