# Home Inspection Report

Property Information: Single Family, 4 bed\*, 1.3/4 bath, 1078 sqft, built 1954.

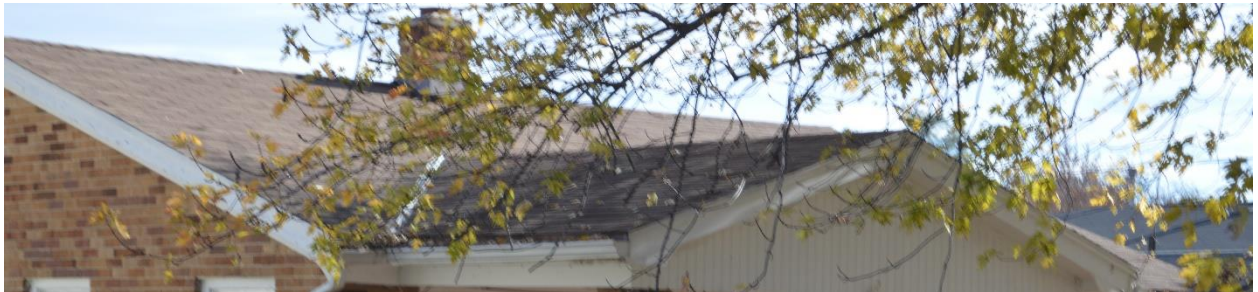
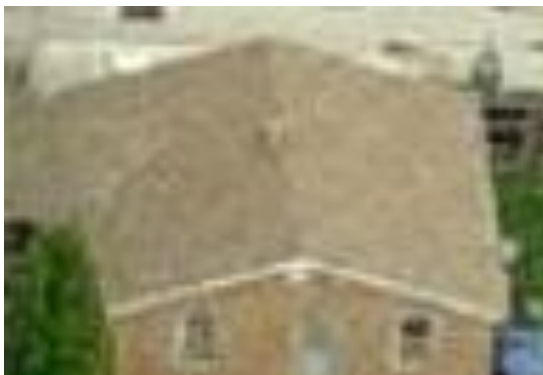
Roof: Fiberglass singles in serviceable condition with no issues found. Roof reported to be 15 years old. No torn shingles or depressions noted in roof.

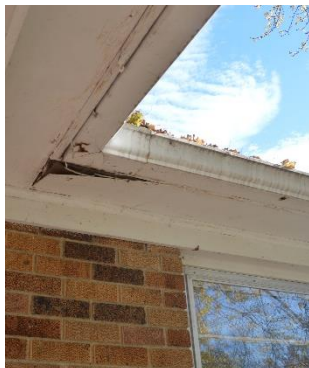
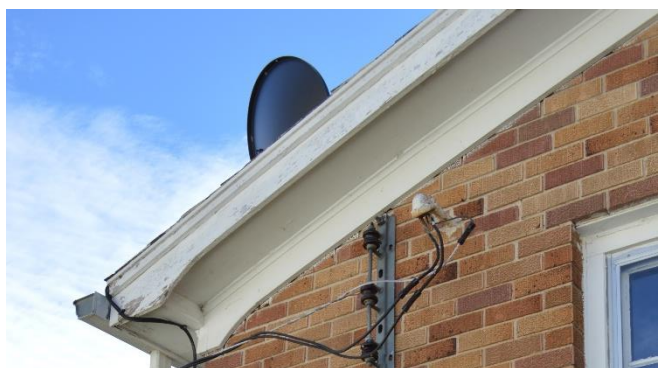
Eaves : Eaves have a couple of areas of deterioration and require paint all around.

- Deterioration at roof eaves. Repair prior to any drywall work inside. Remaining eaves need scrapping and painting.
- Home was inspected for methamphetamines. And trace was found in kitchen range hood or duct work. Need qualified persons to inspect and make safe. This issue has been reported so how it is resolved must be passed on to the final purchaser.

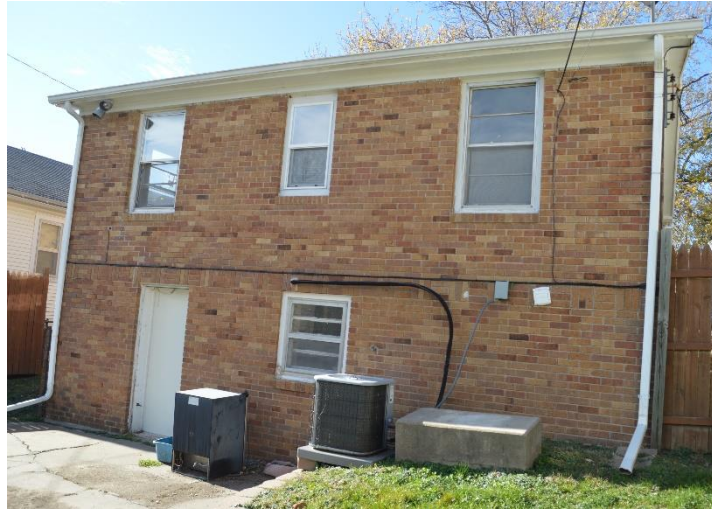
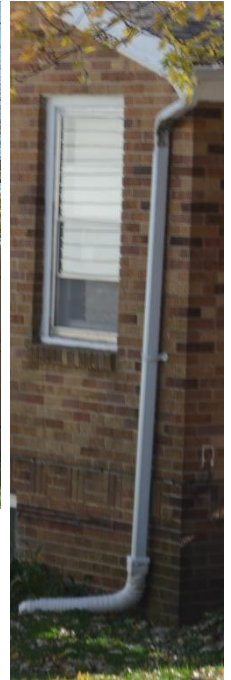
Gutters and down spouts: Despite the eaves being in a condition of needing repair the gutters are in surprising good condition. No dents, separations or evidence of leaking found. Gutters in front of house are piped into the ground. Most likely these are plumbed into the sewer system. East of 72 street Omaha has a combined sewer and storm water system. Note: gutters are full of junk. Need to be cleaned out.

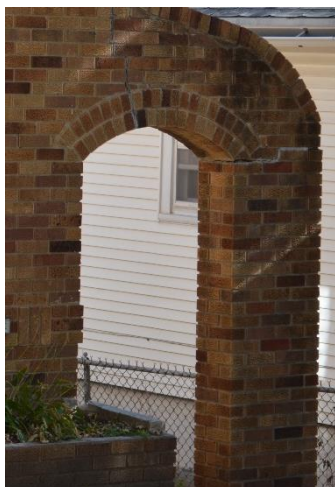
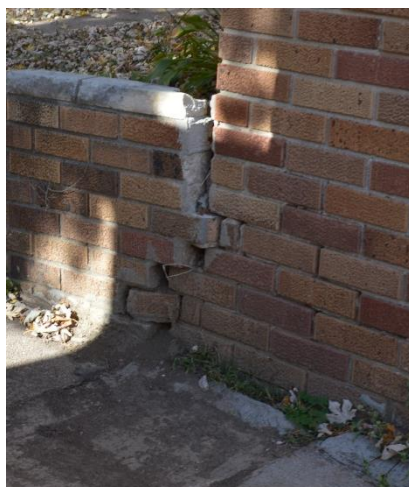
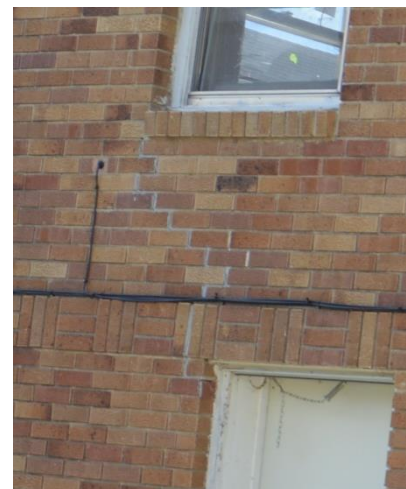
Brick work. There are several full depth cracks in the exterior brick around this house. The arch in the front of the house was tuckpointed and has since cracked again. The flower pot in front of the building has basically fallen off. There is approximately a 3-inch gap. Note; flower pot is not actually part of the building. Can be removed. But this is in the area of the arch. Over the back door is another crack that has been tuckpointed. This crack has remained closed since repairs. There is evidence of severe movement in the building surfaces. Strongly recommend inspection via an engineer or brick layer. Additional brick work is necessary on the south side porch landing.

- Cracking, settling of exterior brick work. This is a serious condition and must be evaluated before any other work.
- Windows. Any serious remodel of house must include replacement of all the houses windows. They are in bad shape. There are a total of 17 windows. This includes the one egress window installed in the basement on the north side.

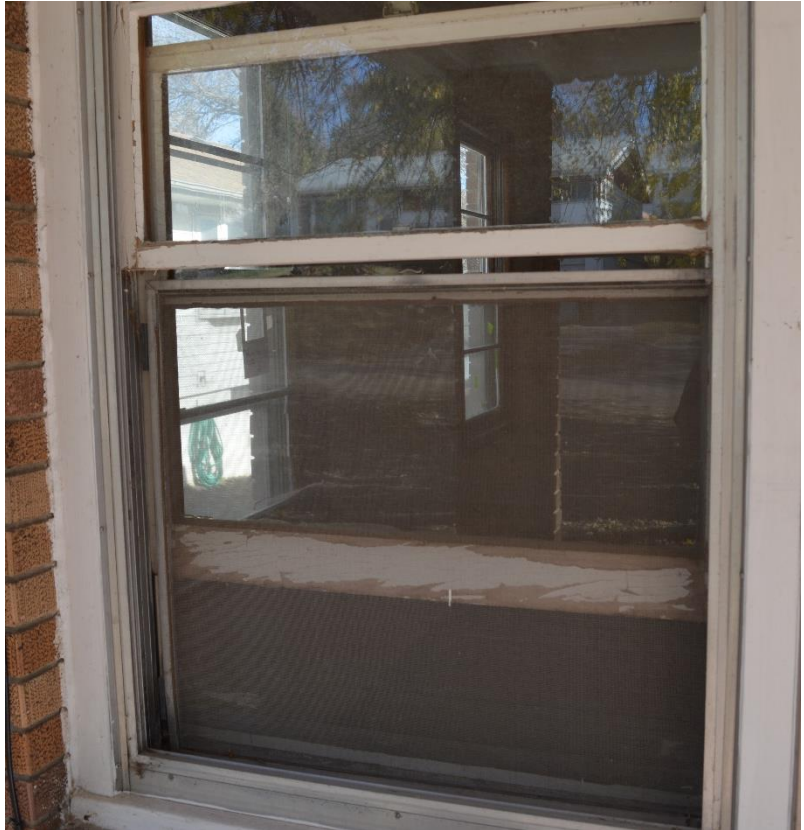
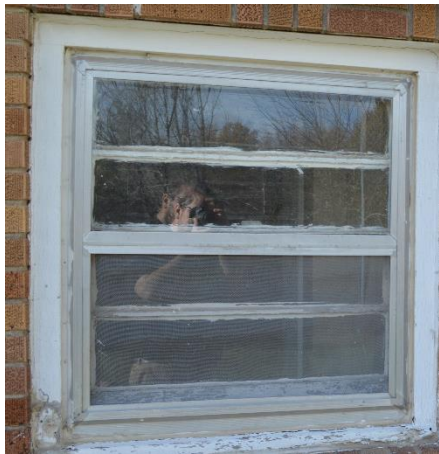
Windows: The windows in this house are original and of wood construction. They are showing their age due to both dry rot and wet rot. The aluminum storms installed in front of the windows are also in bad shape and showing signs of corrosion. Recommend replacing all windows. A good quality vinyl window will replace both window and storm window.

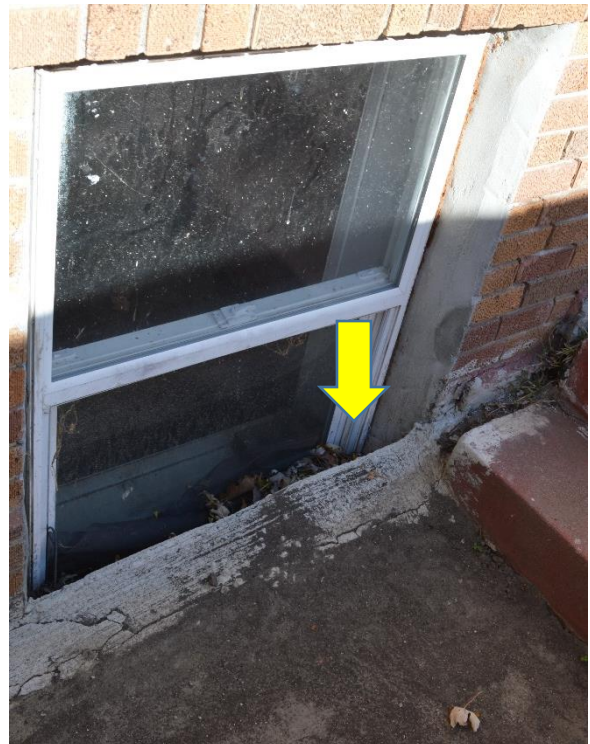
This basement bedroom window is not up to code on 2 very important levels. First the bottom sill is 12 inches below grade. During heavy rains, it will be impossible to keep rain water out. 2<sup>nd</sup>, as this is a bedroom window it must provide a means of emergency exit. As it is currently installed no city official will ever allow it. Condition can be corrected by installing a window well and a new (vinyl) window classified as an emergency egress. Also need to

point out that this window is in the side walk to the side door of the home. If a window well is installed here it will need to be cut into the side walk. Or side walk removed and a new walk poured in after window well is installed. Window well will need a flush mount grill on top to prevent someone from falling into well.

- Illegal bedroom window. Needs new window well and emergency egress exit window. If room is not going to be used as a bedroom bottom of sill needs to be raised to grade level at minimum.

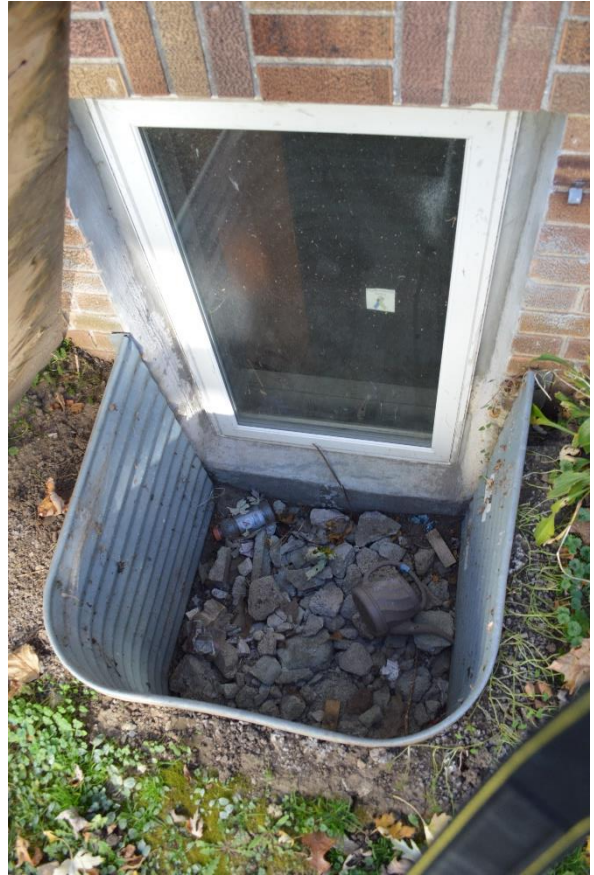
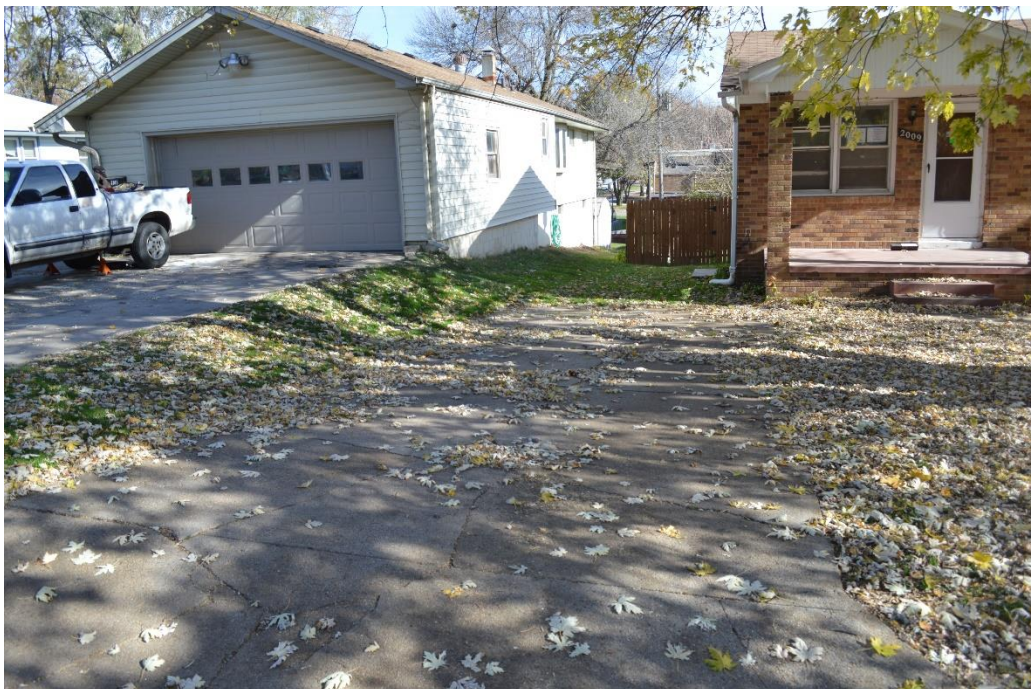
Here is a picture of a window with a window well on the opposite side of the house. This window is a newer vinyl window and may be salvageable.

Note: There is no garage but there is a short driveway or parking space off street on the north side of the home. Concrete is in serviceable condition. Many cracks but all are level. No tripping hazard.

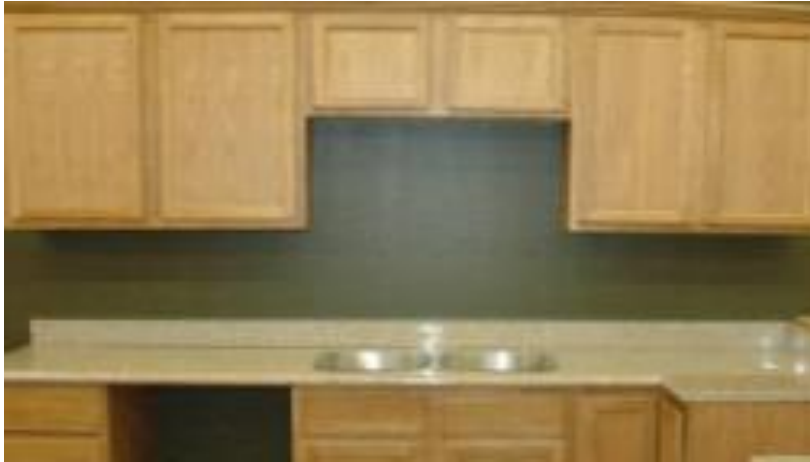
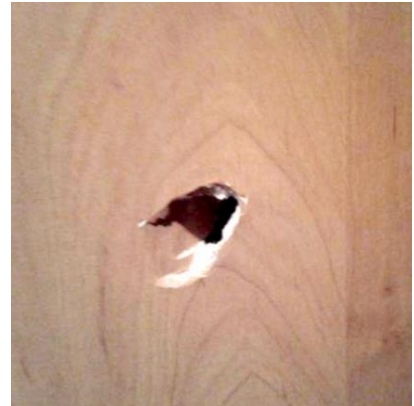
There is a very nice small modern kitchen installed. However, one of the cabinet doors has a hole punched into it. Need to determine manufacturer of kitchen and find out if replacement door can be purchased.

Kitchen Range Hood Tested positive for methamphetamines. Need to determine if hood and ductwork can be safely cleaned or if items need to be replaced. There is a safety concern for anyone exposed to these chemicals. Finally, there is a dishwasher in the kitchen. Since it has not operated in over a year it is non-viable and will need to be replaced.

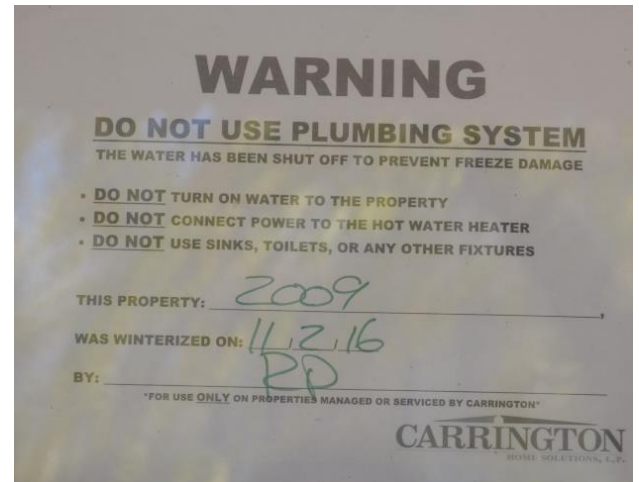
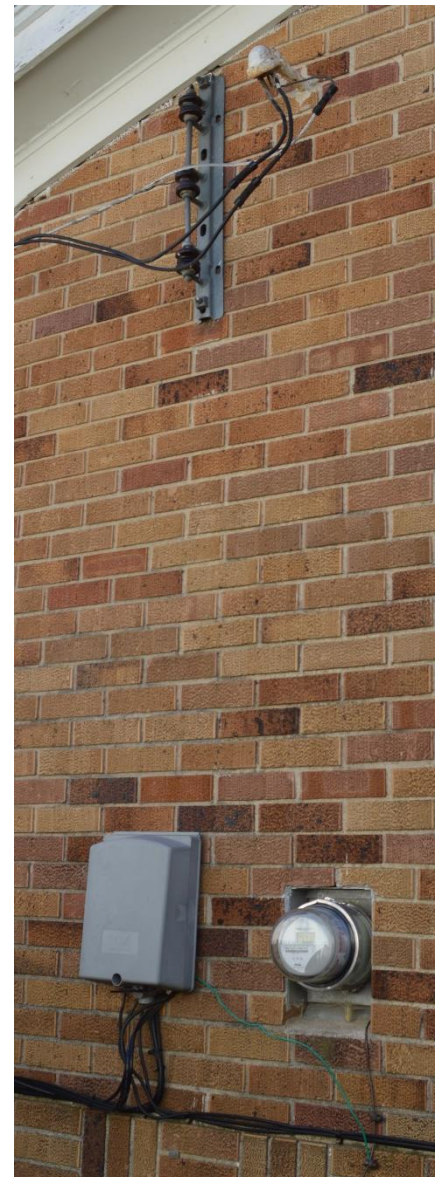
Electrical: Found some cloth Romex. Also, found some newer wiring so house has a mix. There are electrical boxes in the middle of walls. Electrical panel is about 15 years old so not original to the house but is clean. If most the existing wiring can be saved the panel may not need to be replaced. Since there are boxes in the wrong places and older clothe wiring recommend further inspection by a licensed electrical contractor.

With plastic water piping 2<sup>nd</sup> required grounding of panel may have been lost. Only found one ground outside.

- Electrical, Cloth wiring and incorrectly placed boxes. Need the assistance of a licensed electrical to evaluate and repair or replace as necessary.
- HVAC equipment has not operated in over a year. Need the assistance of a licensed plumber to evaluate and repair replace as necessary.

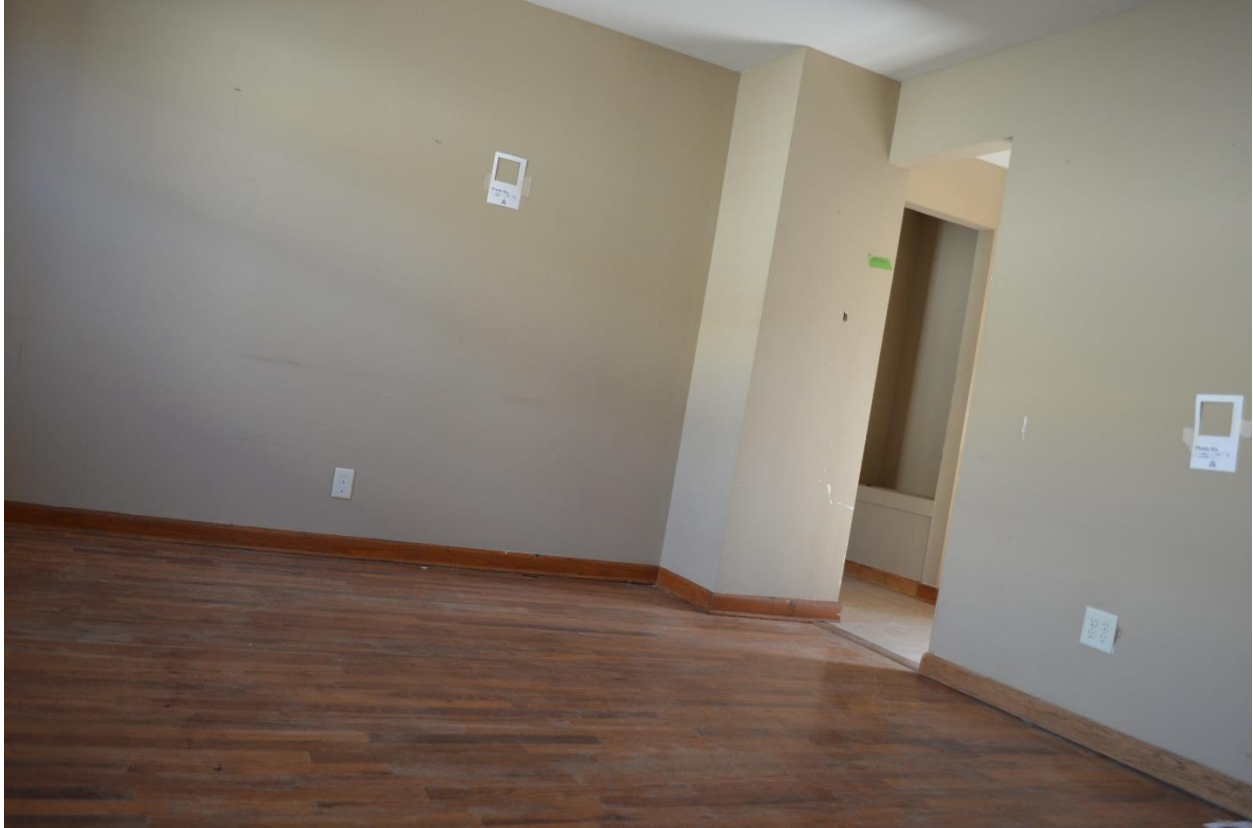
Front room wood flooring is actually in good shape. All remaining flooring will need to be replaced. Stains, tears and out of date to name some problems.

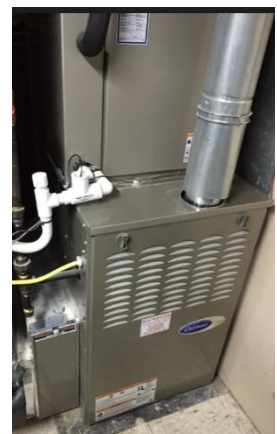
Closet that furnace is in, is tight but functional. Doors are accordion vinyl. Not fire proof and air tight when closed. There are combustion air vents on the sides of the closet but install was sub-standard and one of the vents is falling off the wall.

Recommend cleaning up closet, and enlarging if possible. At minimum new doors and vents should be installed.

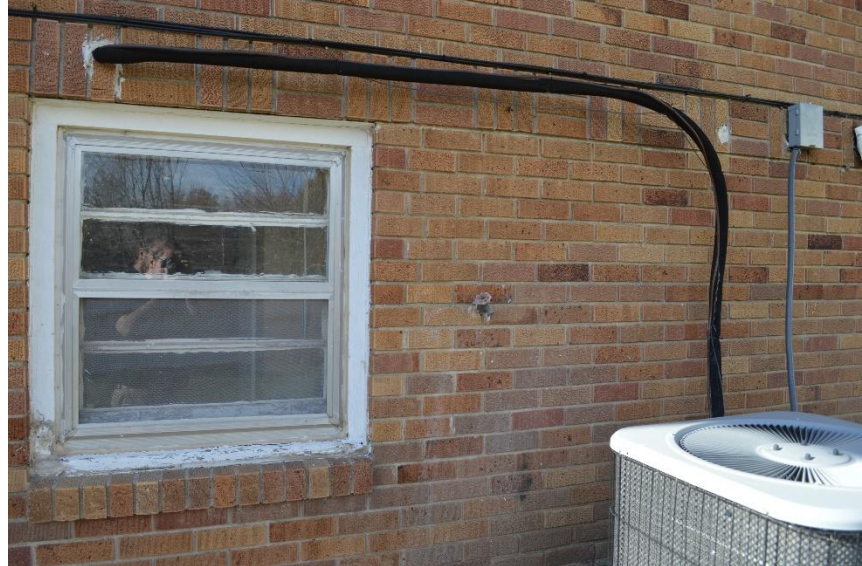
AC refrigeration lines outside are not supported on side of house. Entire weight of lines is held up by air conditioning unit. This is an unacceptable condition.
