# Home Inspection Report

- Address
- City, State, Zip
- Date:

Property Information: Single Family, 3 bed, 1.5 bath, 1358 sqft, built 1992

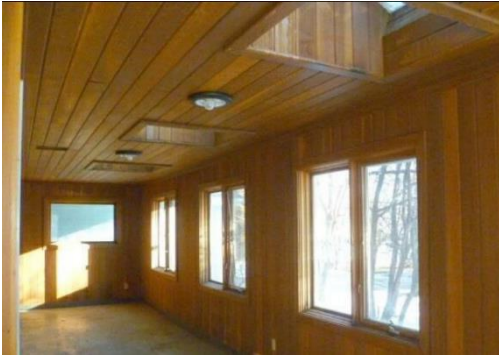
There's even a place to  
Plant your plants. There  
However, there is an odor  
to the porch. Need to take humidity readings and  
determine if further action is necessary. I would  
also look at removing the dirt as the smell was  
most significant in this area.

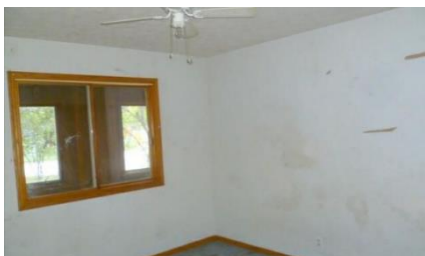
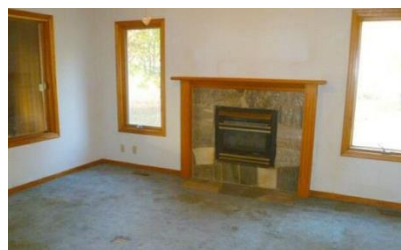
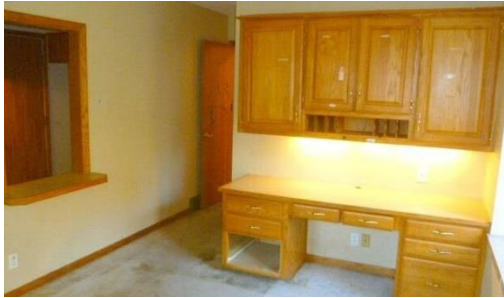
Notice the porch in the window of these pictures.
