- Home Inspection Report #1
 - Address
 - City, State
 - Date:

Property Information: Single Family, 3 bed, 1.5 bath, 1128 sqft, built 1963

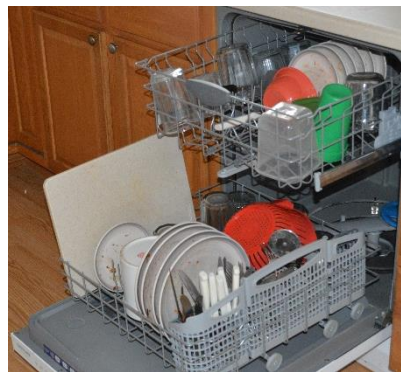
Appliances are midgrade, clean, Maytag brand (refrigerator with through the door ice and water, gas stove with oversized oven and over the range microwave oven). Dishwasher is large capacity Kitchen Aid and is a newer

install. Dishwasher was running during inspection and is fairly quiet. In addition, there

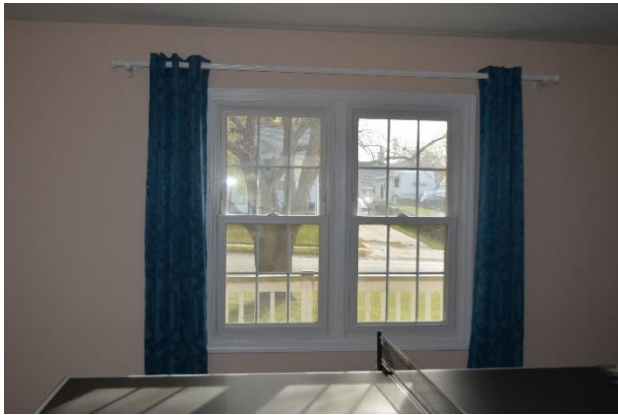
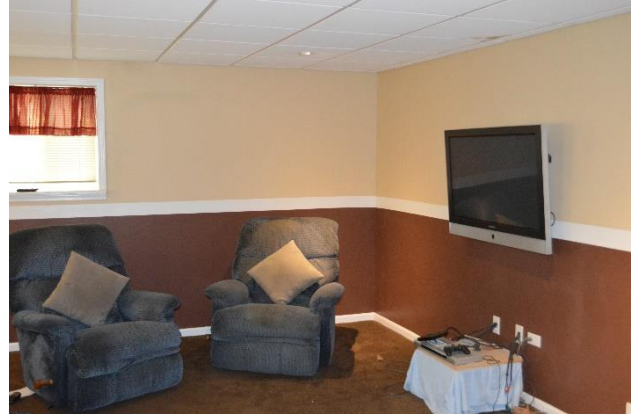
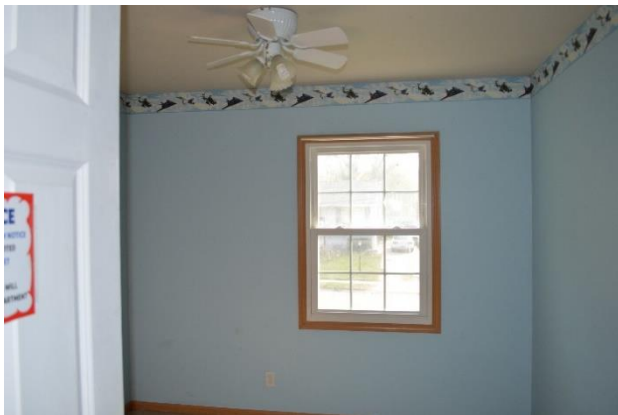
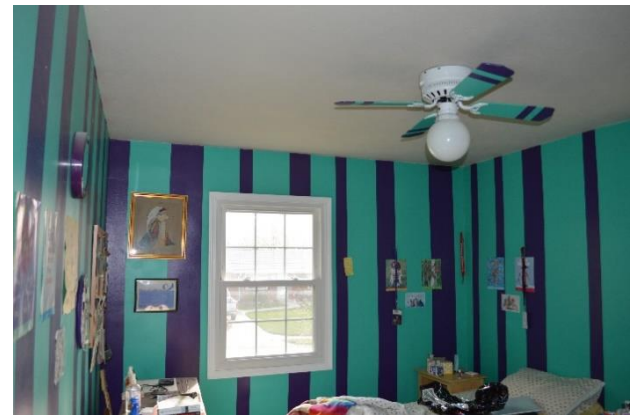
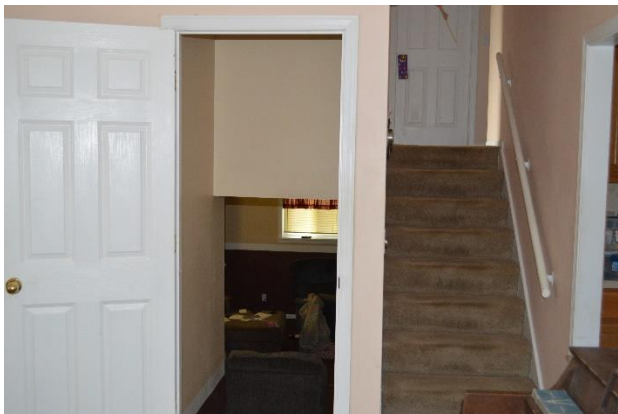
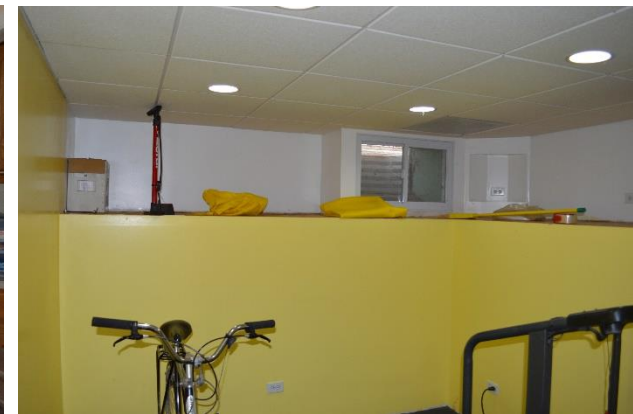
Interior drywall and trim is in very good condition. No issues found. Colors are mostly neutral. Kids bedrooms are a little wilder. Door and trim paint is also in serviceable condition. Stairway

railing to lower level family room needs to be painted. All bedrooms have ceiling fans on independent switches.

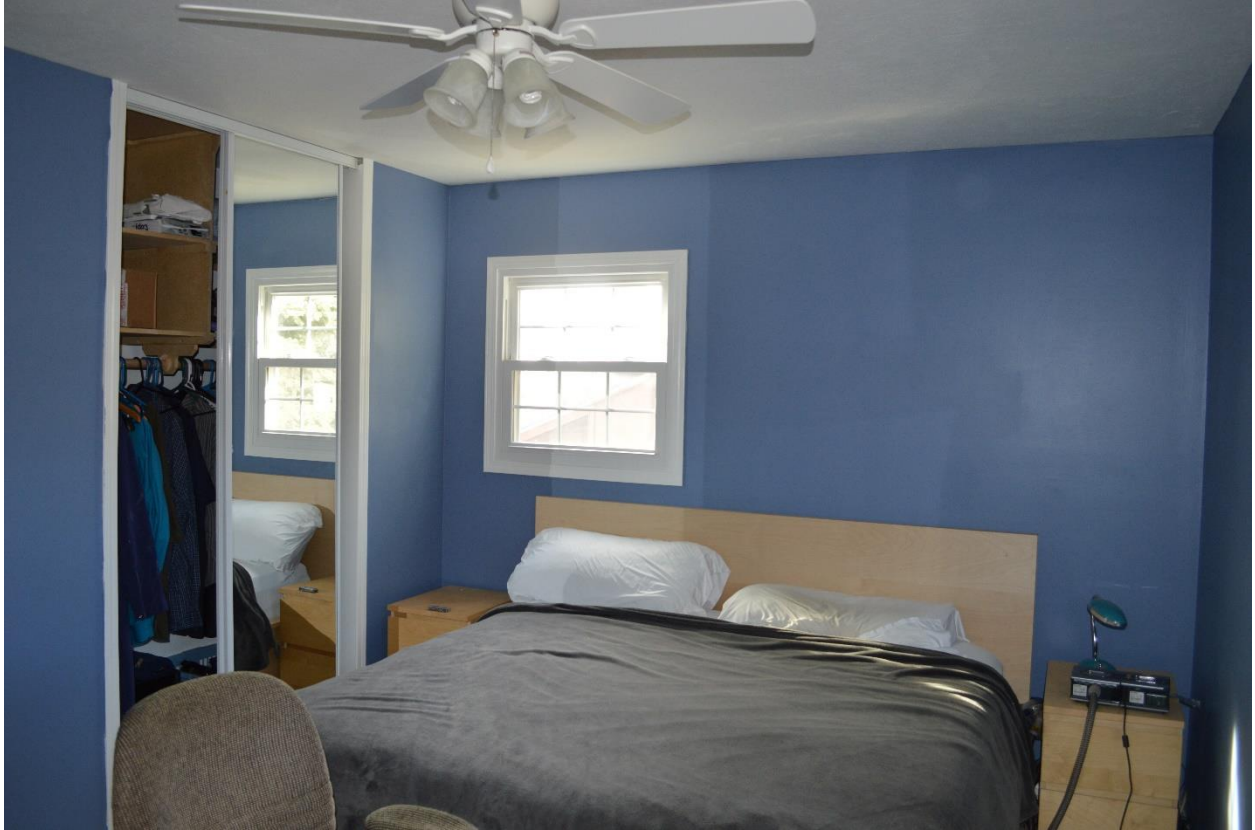
Flooring: Bedrooms, stairs, front room, stairs and family room are all carpeted. Carpet is older but in very good shape. Family room carpet is new. Both bathrooms have ceramic tile in serviceable condition. There is a cracked tile in hall bath next to floor vent. Kitchen has veneer wood flooring. Is worn thin in a few places. Linoleum flooring in mechanical /laundry room should be replaced. Very thin and torn in several places from furniture or appliances. Lower level craft / exercise room has commercial carpet squares in good condition. Storage room is concrete.
